Manhole Inspection Summary

Manhole # S61Q__002MH

Insp Date: **12/30/08 10:06 AM**

Location Address: **Boston St.**

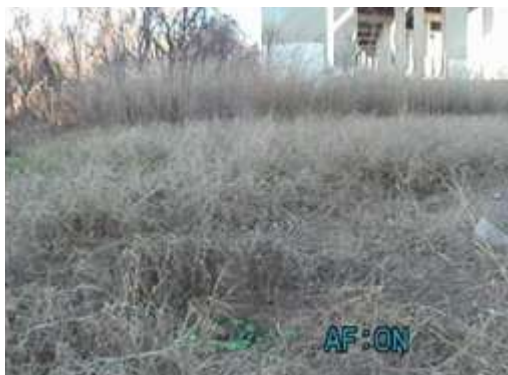
Location View

Comments **HEAVY PONDING FROM BEING DUG UP AND BELOW GRADE. INCOMING 5 O'CLOCK LINE SEEMS TO BE AN OLD ABANDONED LINE.**

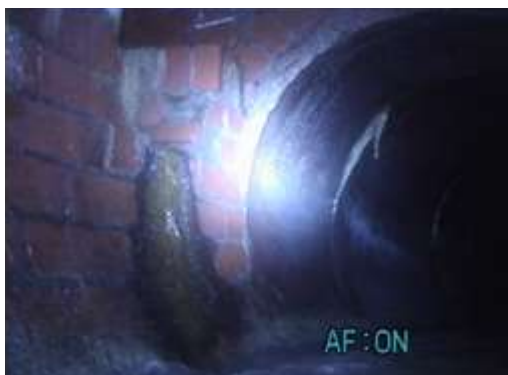
Defect 1

Condition: ☐ Sound ☒ **Cracked** ☐ Root Intrusion ☒ **Deteriorated** ☒ **Leaks** ☒ **Debris**

Infiltration stain from bench by the O12

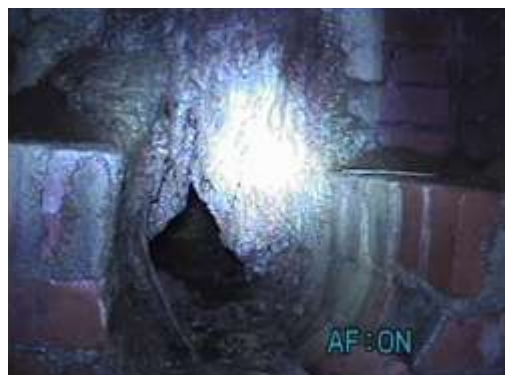
Defect 5

encrustation of I-10

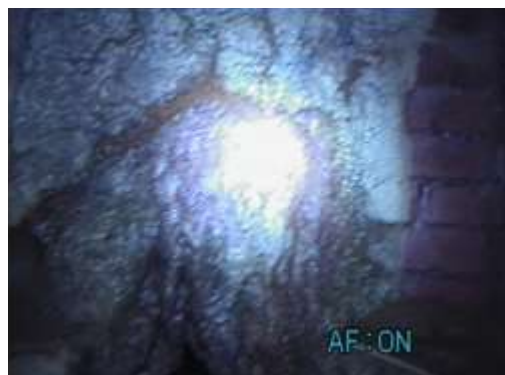
Defect 4

encrustation on barrel wall

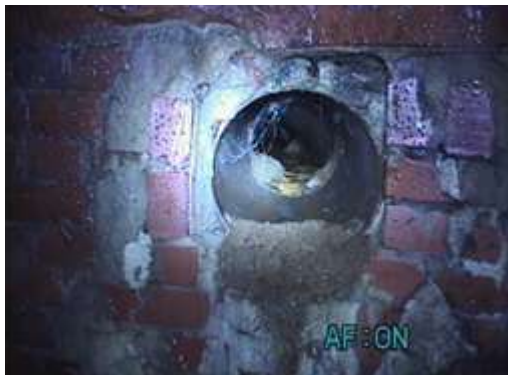
Defect 6

Infiltration around I9

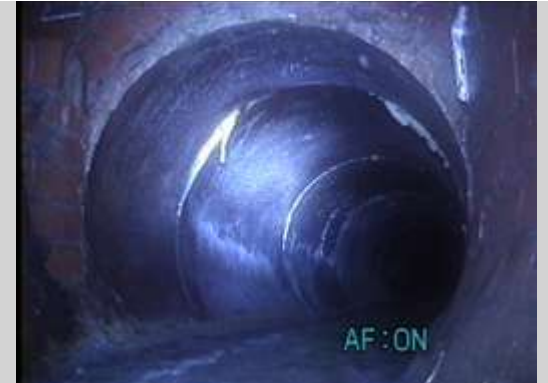
12 O'Clock Outflow

Pipe Height: **27.6** (in.) Rod and Bar (Angled)
Pipe Material: **Clay** ☐ Pipe Lined
Invert Depth: **17.42** (ft.) Flow Characteristics: **Fast**
Deposits: ☐ None ☒ **Mud** ☐ Sludge ☒ **Debris** ☐ Grease
Silt Depth: **1** (in.) Deposits Extent: **Medium**
Infiltration: **None** Pipe Seal Cond: **Sound**

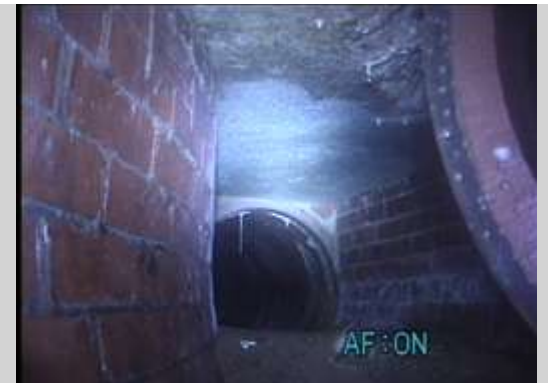
5 O'Clock Inflow

Pipe Height: **24** (in.) Rod and Bar (Angled)
Pipe Material: **Clay** ☐ Pipe Lined
Invert Depth: **17.17** (ft.) Flow Characteristics: **None**
Deposits: ☐ None ☒ **Mud** ☐ Sludge ☒ **Debris** ☐ Grease
Silt Depth: **4** (in.) Deposits Extent: **Medium**
Infiltration: **None** Pipe Seal Cond: **Sound**

Connects To: **Stub connection / abandoned**

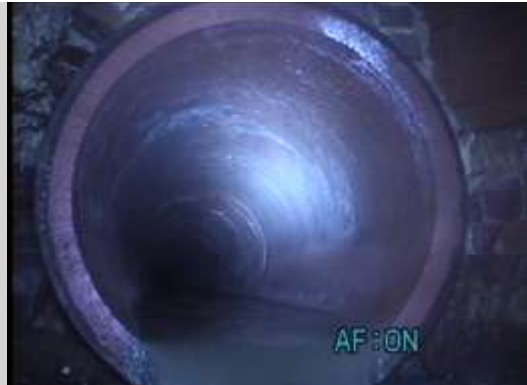
6 O'Clock Inflow

Deposits: ☐ None ☐ Mud ☐ Sludge ☒ Debris ☐ Grease

Silt Depth: **2** (in.) Deposits Extent: **Medium**

Infiltration: **None** Pipe Seal Cond: **Cracked**

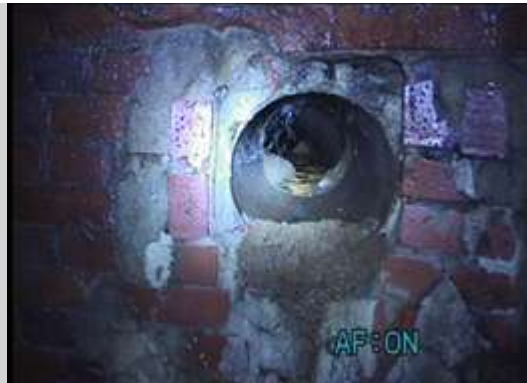
9 O'Clock Inflow

Deposits: ☐ None ☐ Mud ☐ Sludge ☐ Debris ☒ Grease

Silt Depth: **0.25** (in.) Deposits Extent: **Light**

Infiltration: **Evidence** Pipe Seal Cond: **Cracked**

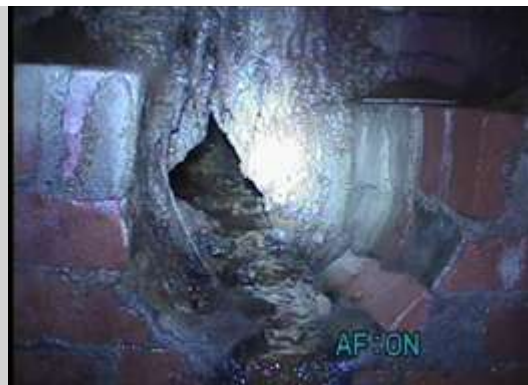
10 O'Clock Inflow

Deposits: ☐ None ☐ Mud ☒ **Sludge** ☐ Debris ☒ **Grease**

Silt Depth: **0.5** (in.) Deposits Extent: **Light**

Infiltration: **Evidence** Pipe Seal Cond: **Unknown**
